# Guidelines for **managing asbestos related health and safety risks** at work

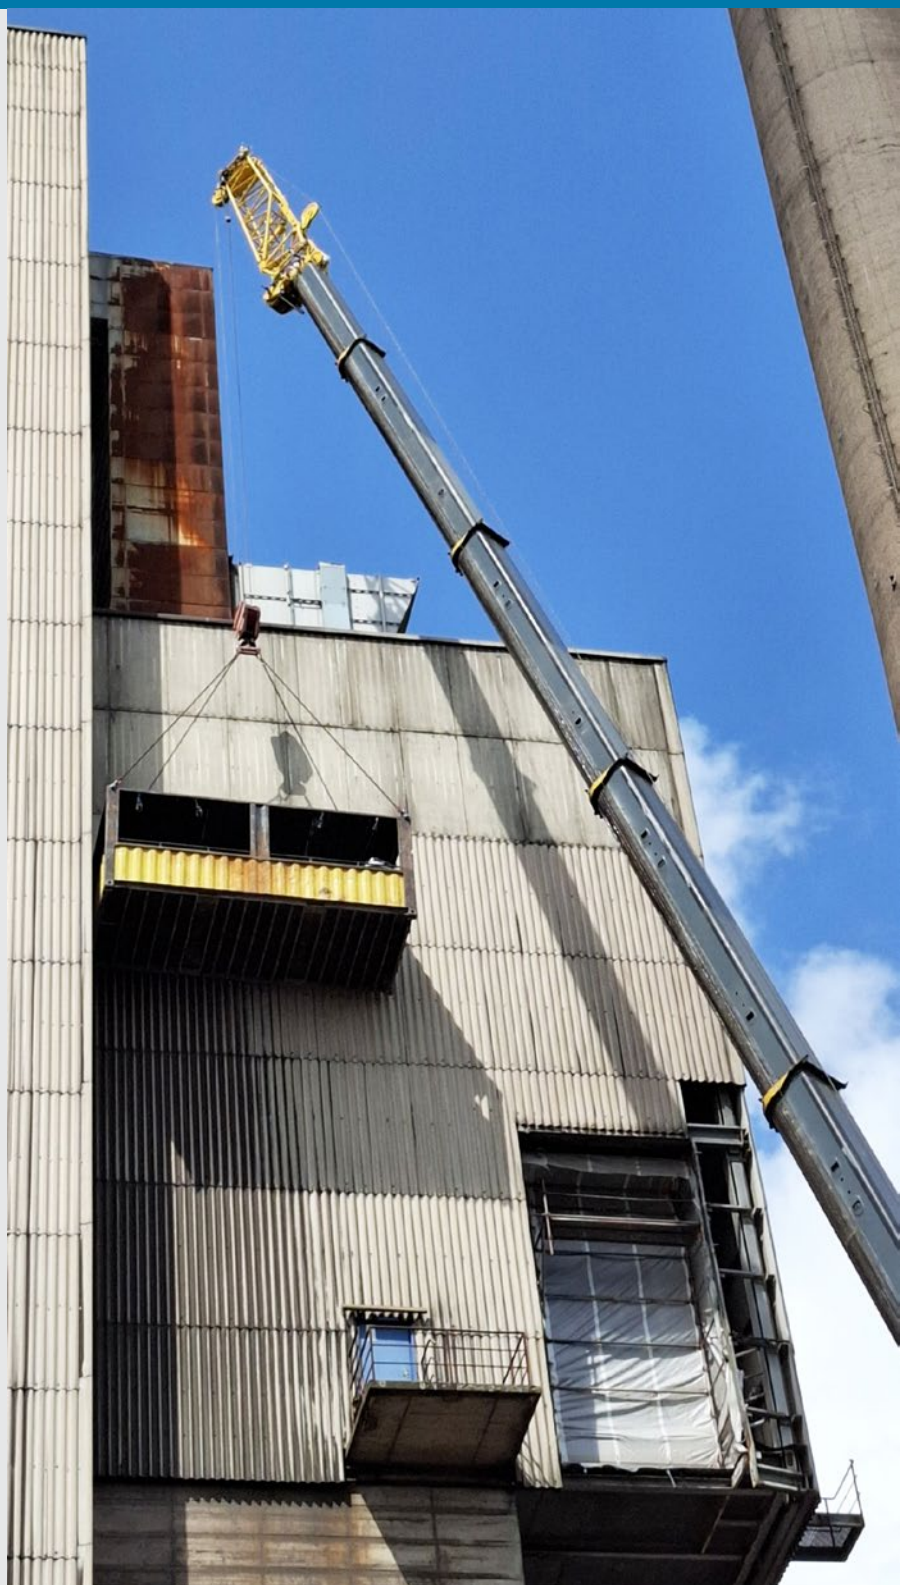
**Figure 4-2: Example of the risk of working at heights during the removal of asbestos plates during the demolition of a power plant in Germany**

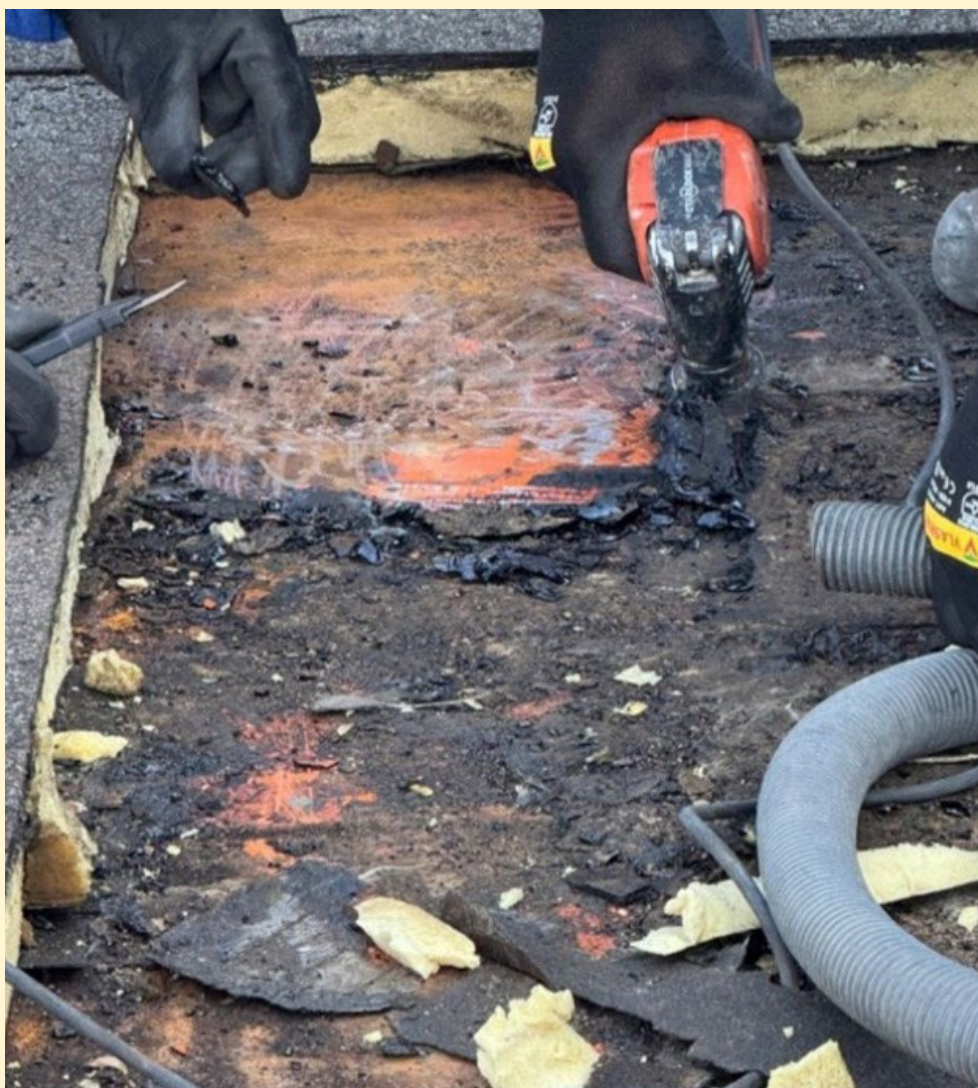
**Figure 4-3: Removal of roofing materials containing asbestos, with metal supportive roof visible**

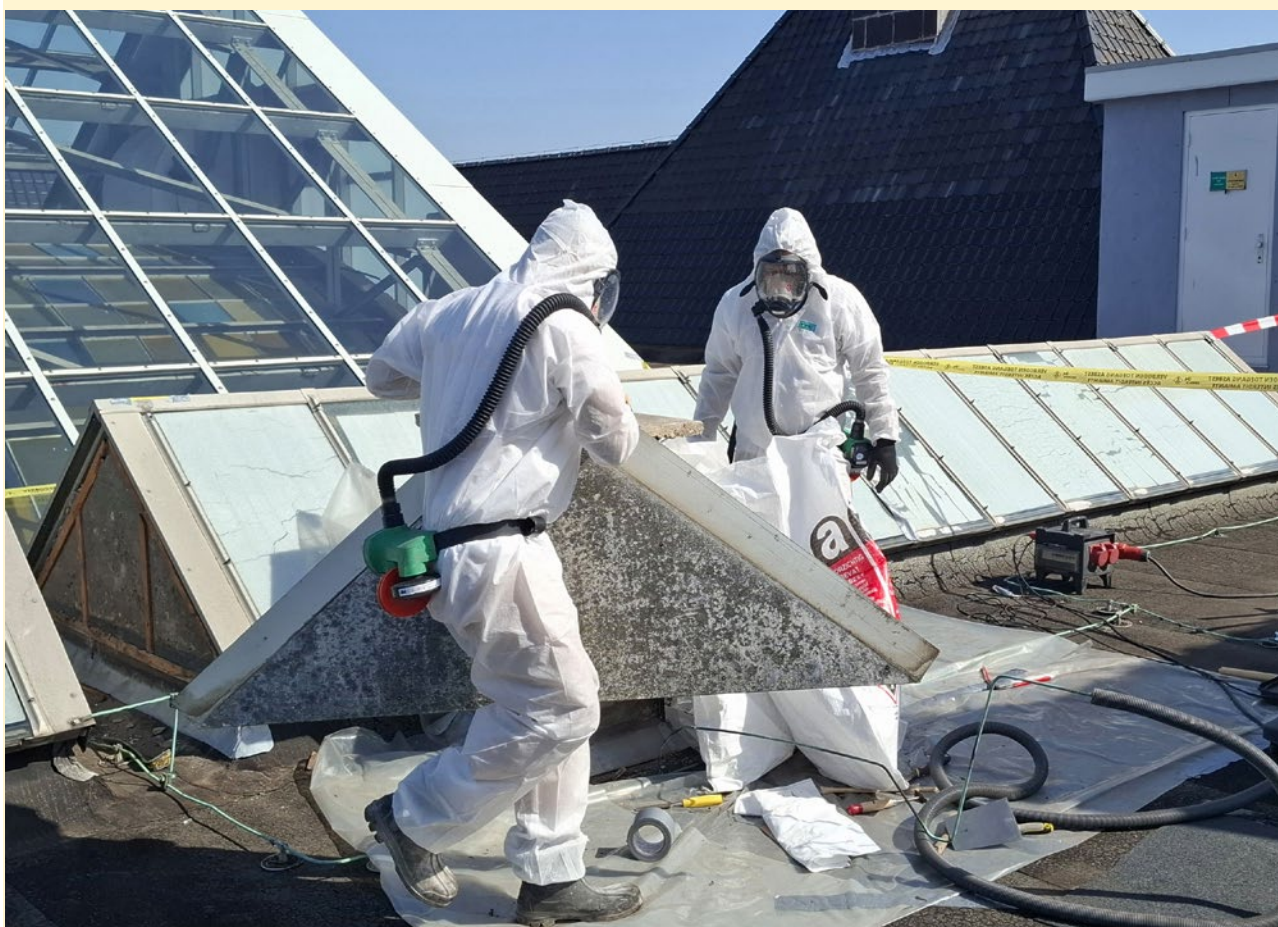
Figure 4-4: Workers removing asbestos plates on the roof

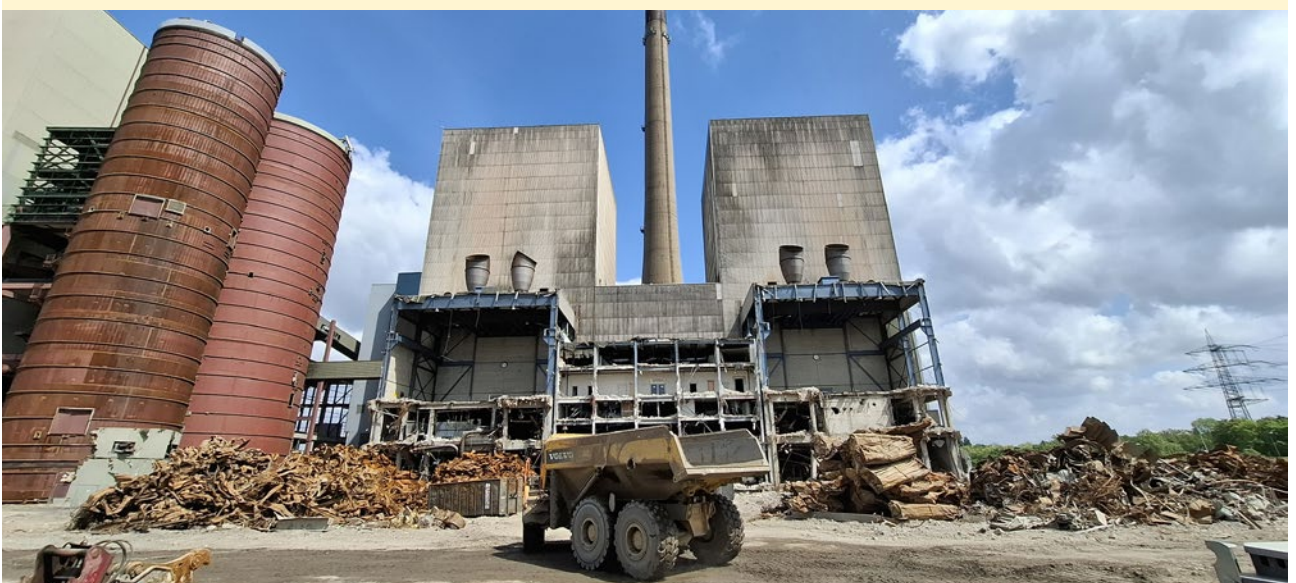
**Figure 4-5: Overview of part of the demolition process at a coal plant in Germany**

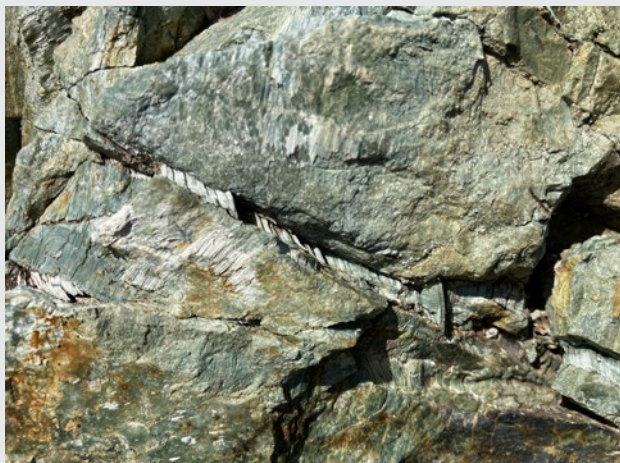
**Figure 5-4: Chrysotile cross-vein in serpentinites (France)**

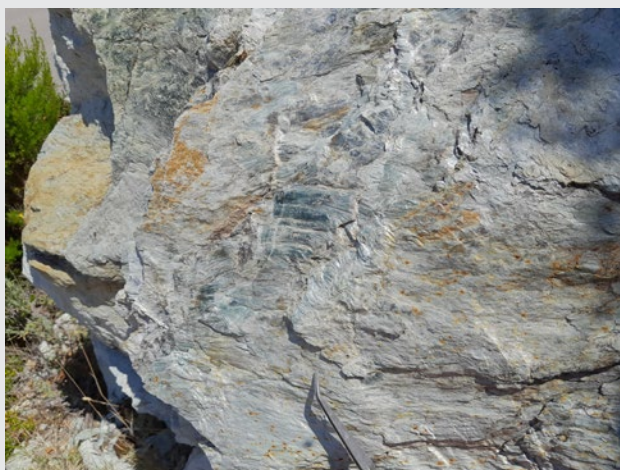
**Figure 5-5: Alumino-magnesian metagabbros with tremolite asbestos**

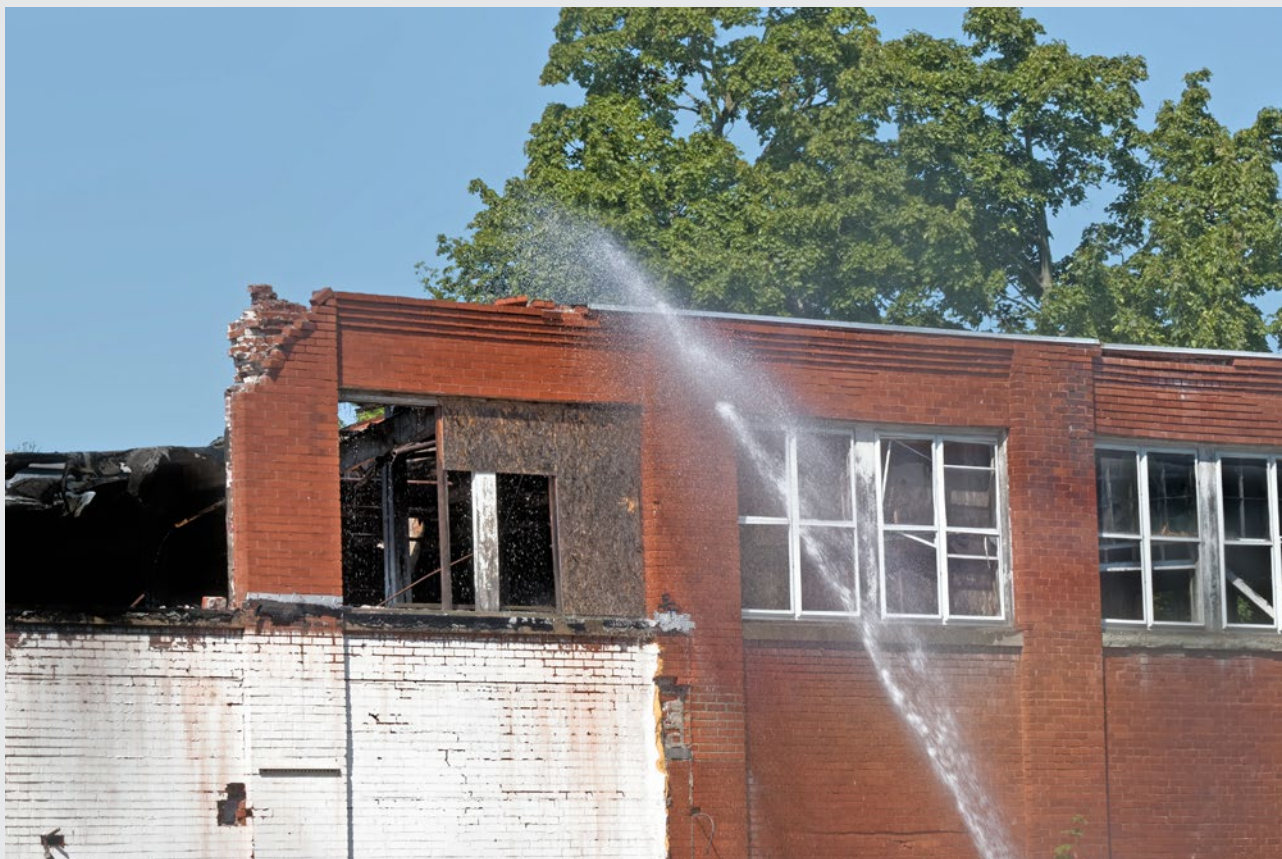
**Figure 8-1: Example of wetting a building containing asbestos**

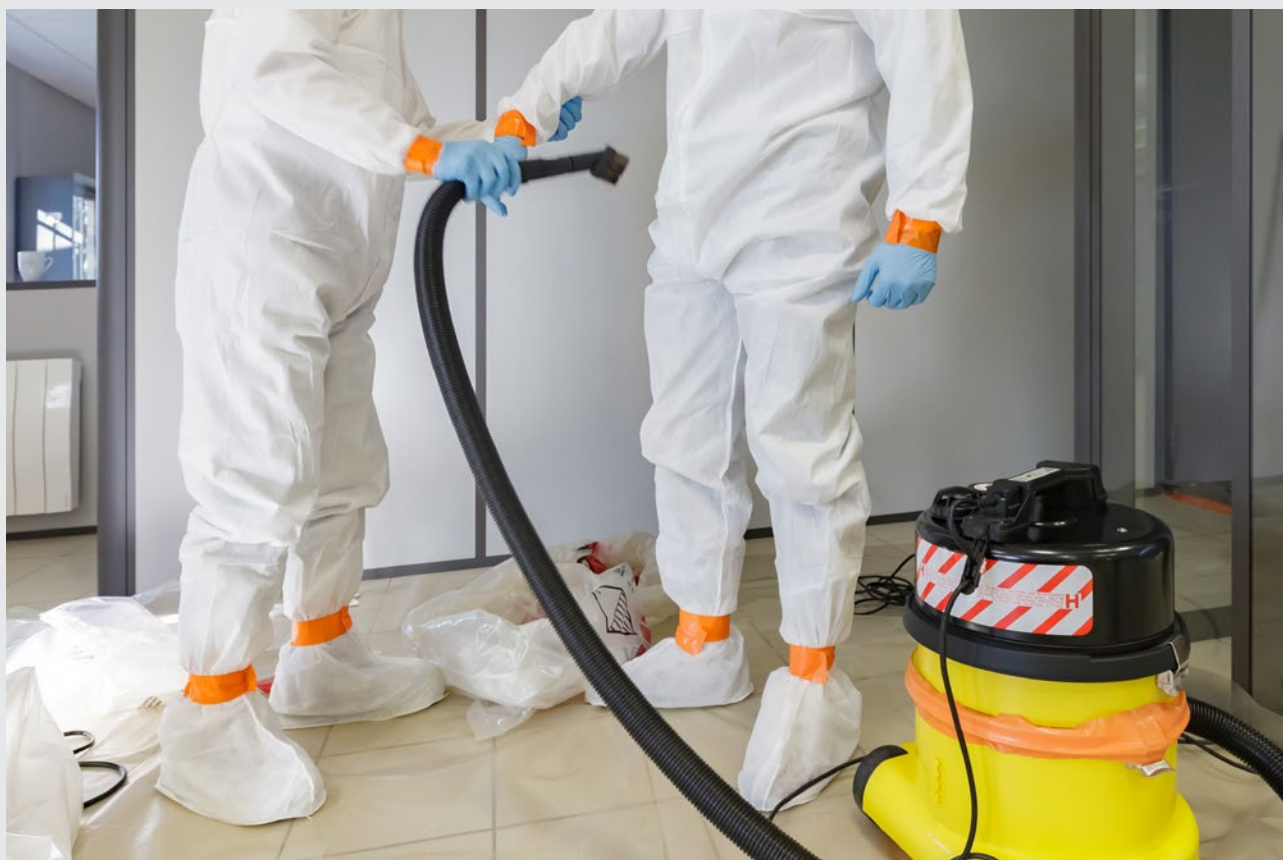
**Figure 8-6: Example of cleaning using a vacuum cleaner**

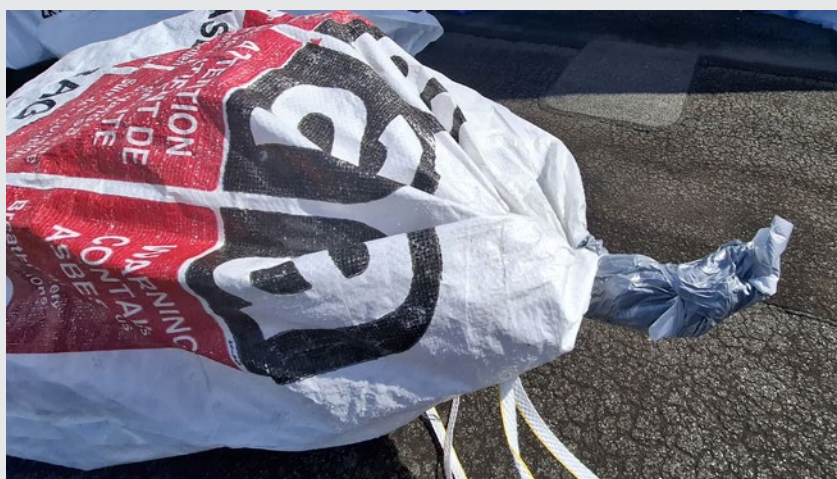
**Figure 8-7: Image of a WCA bag tied with a gooseneck closure**

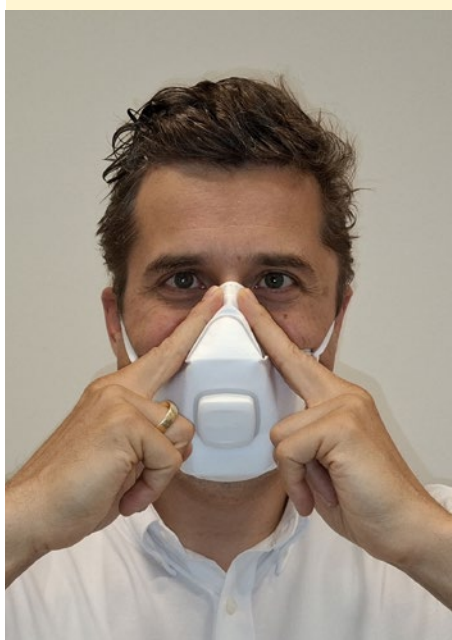
**Figure 8-10:**  
Ensuring a proper seal

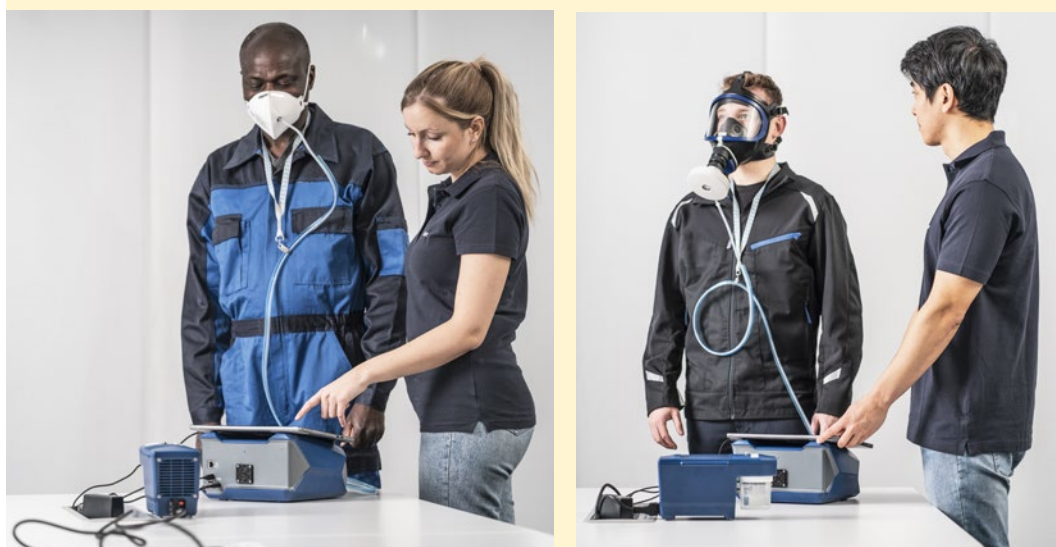
Figure 8-12: Examples of face-fit testing for full face mask and filtering facepiece

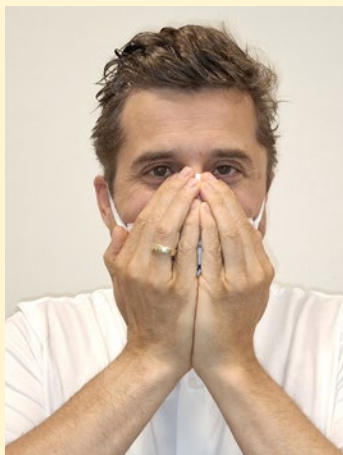
**Figure 8-13: Pre-use check for leakages for an FFP3 mask**

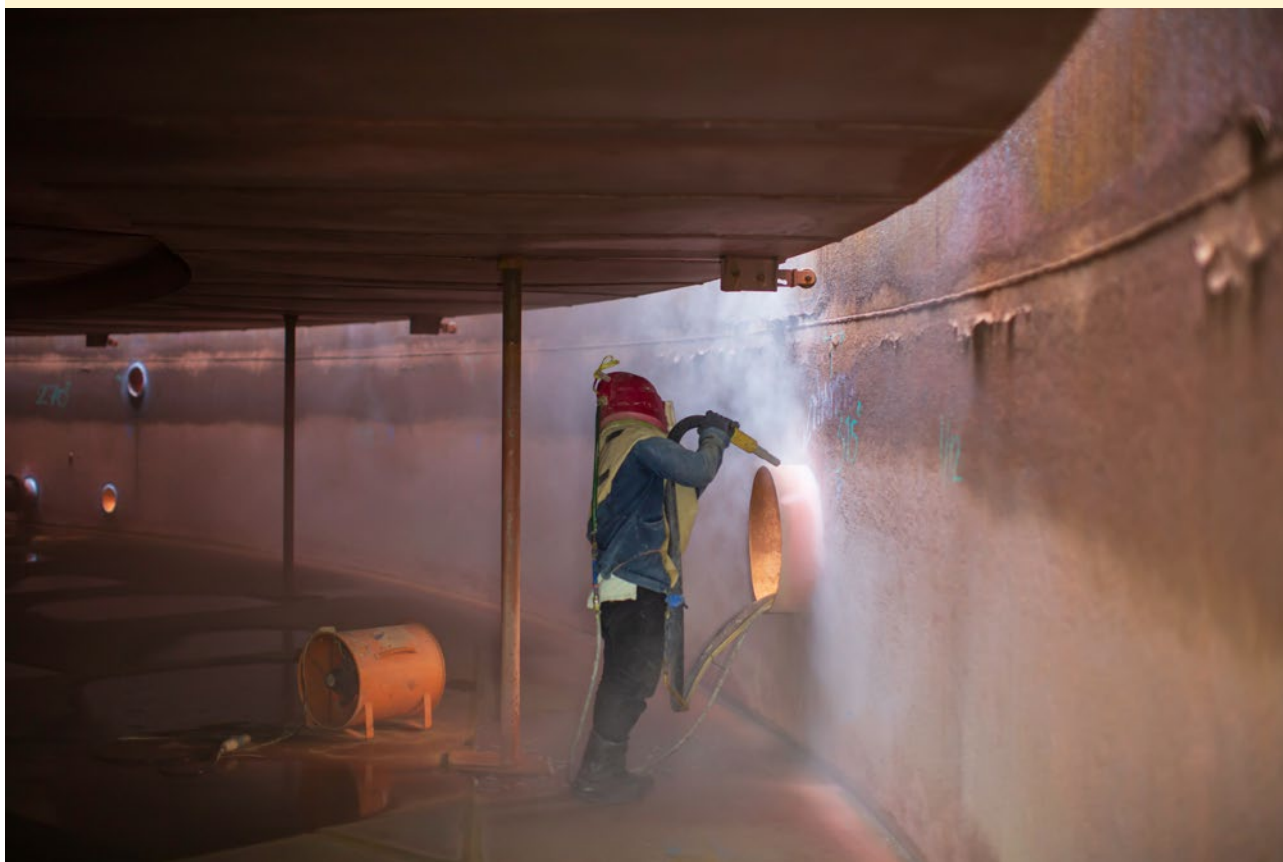
Figure 11-1: Worker removing paint inside of a fuel storage tank using blasting grit

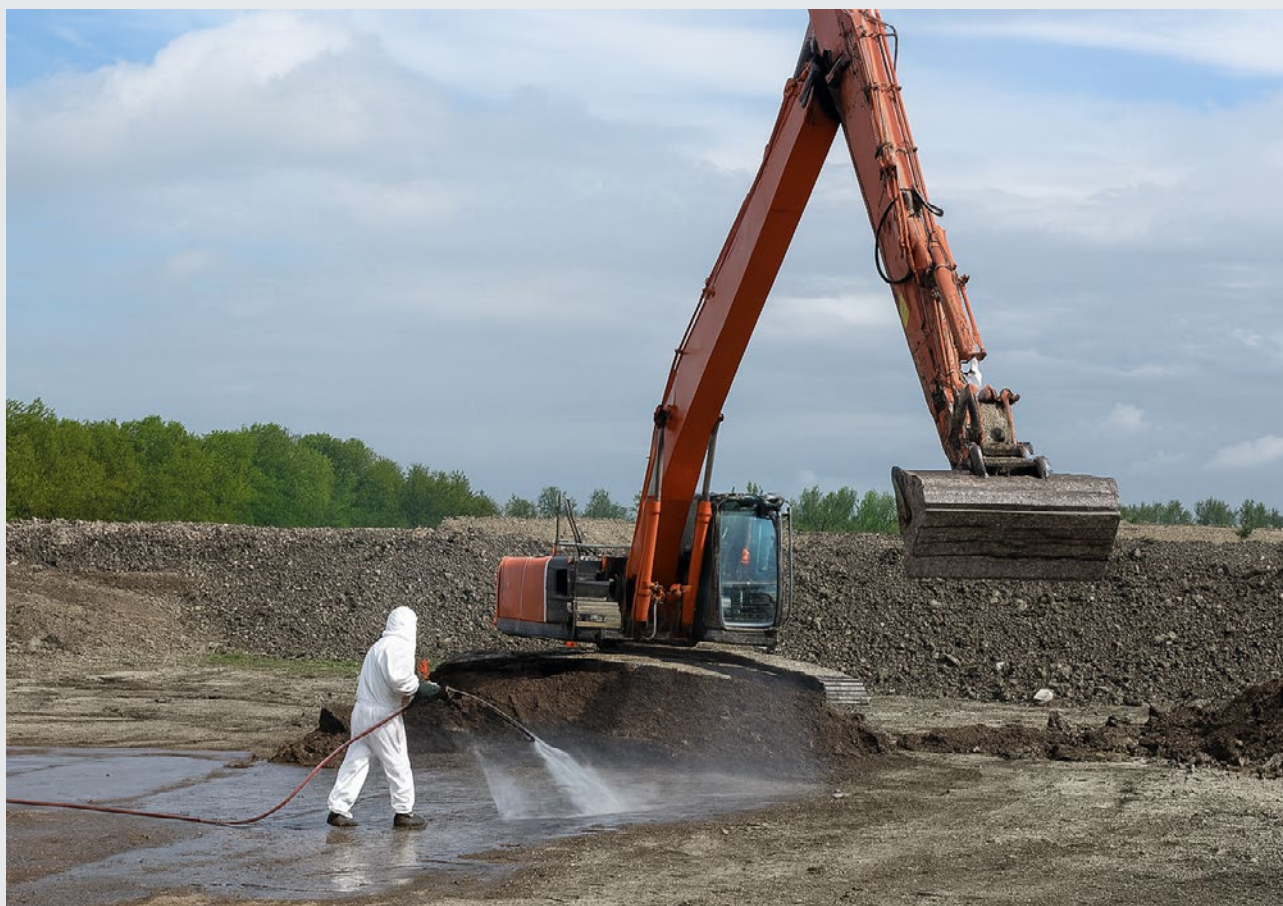
Figure 12-2: Wetting of WCA to prevent dust

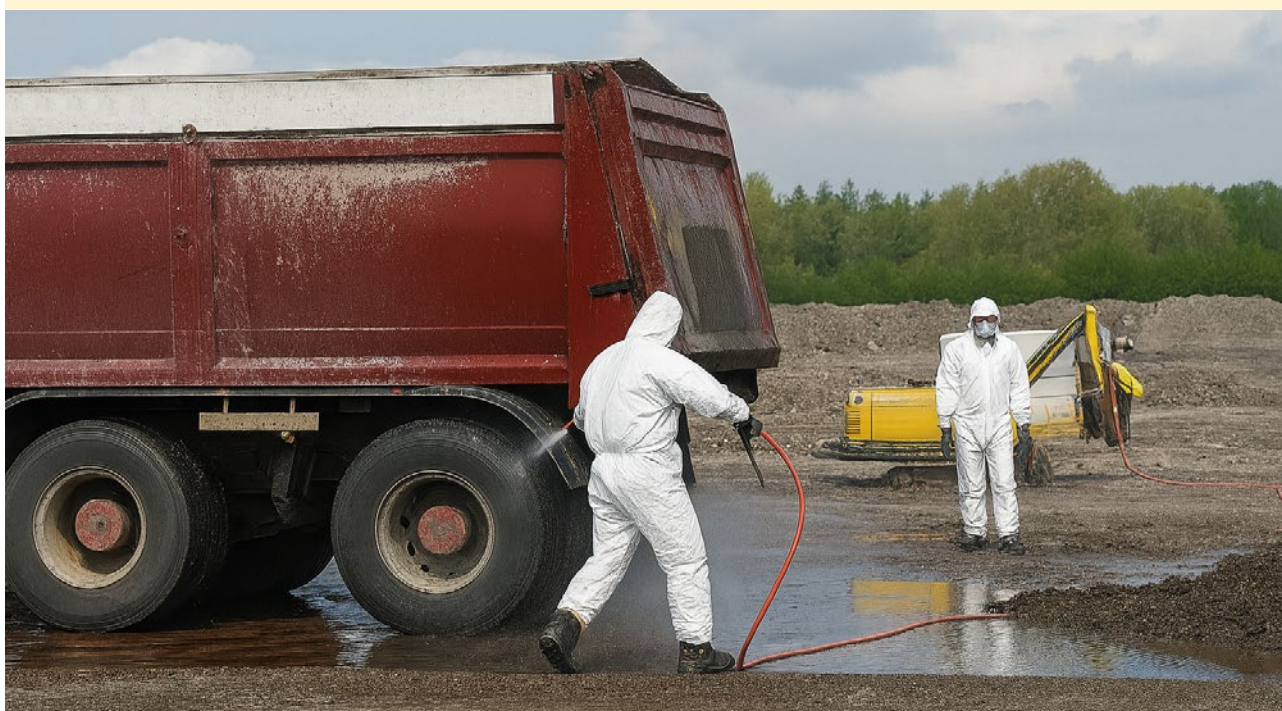
Figure 12-4: Vehicle cleaning

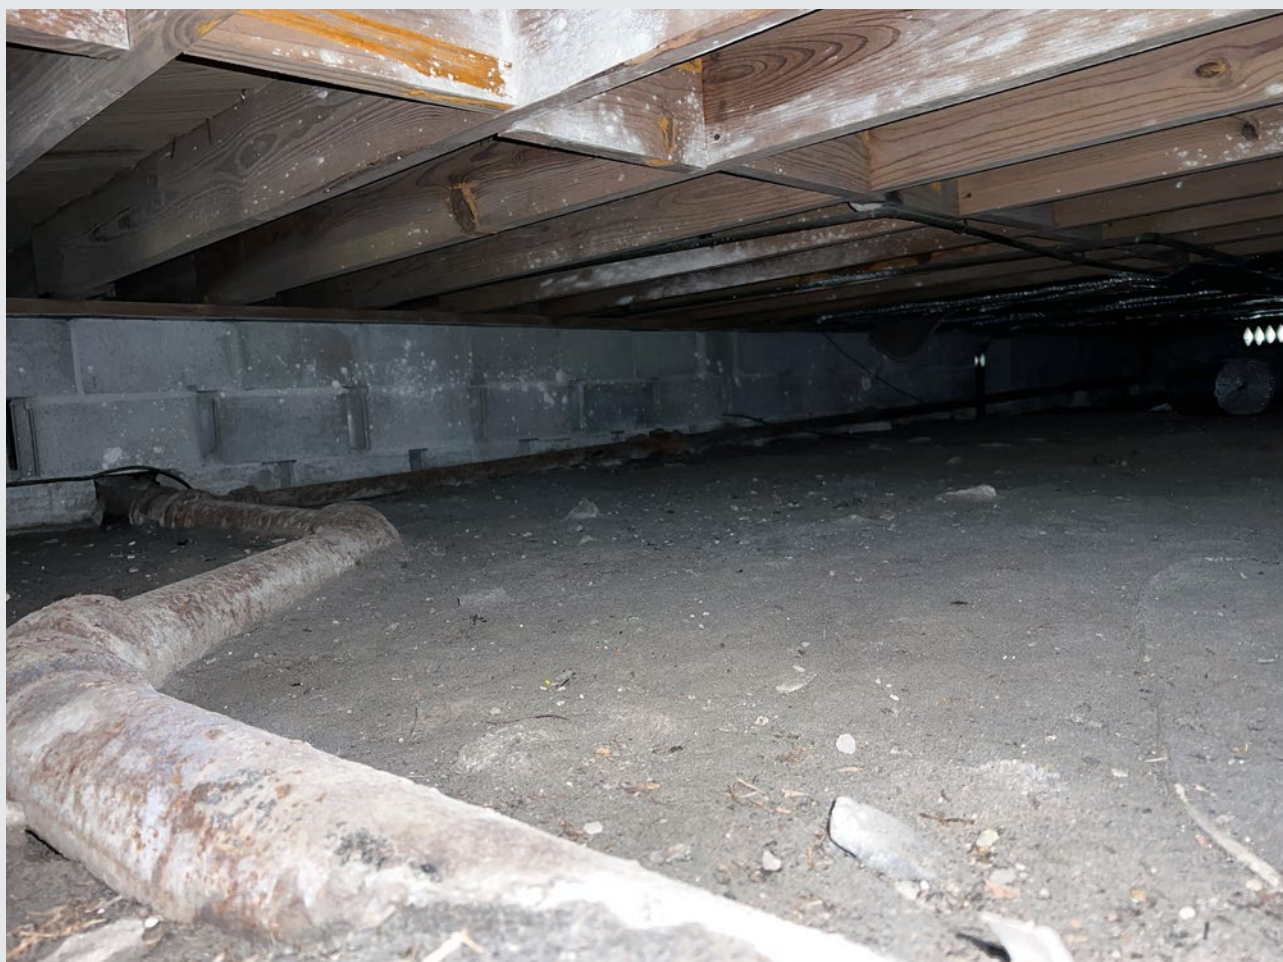
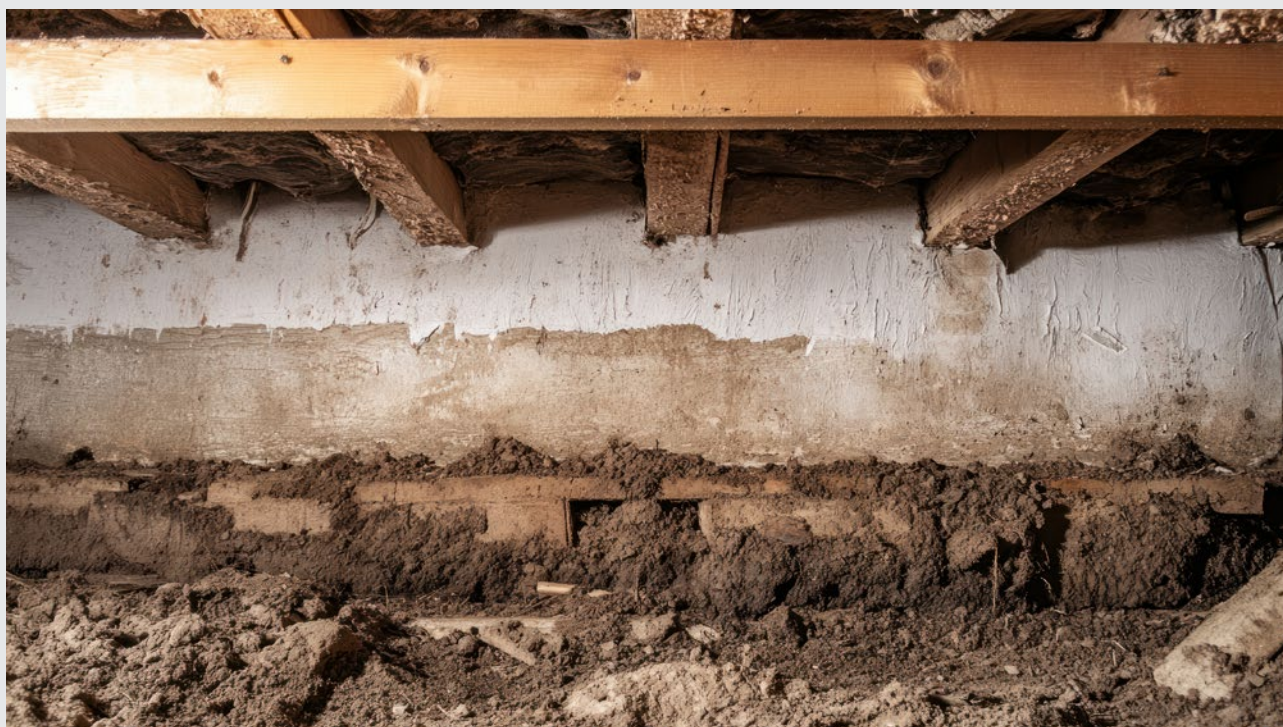
Figure 13-3: Work in crawl spaces

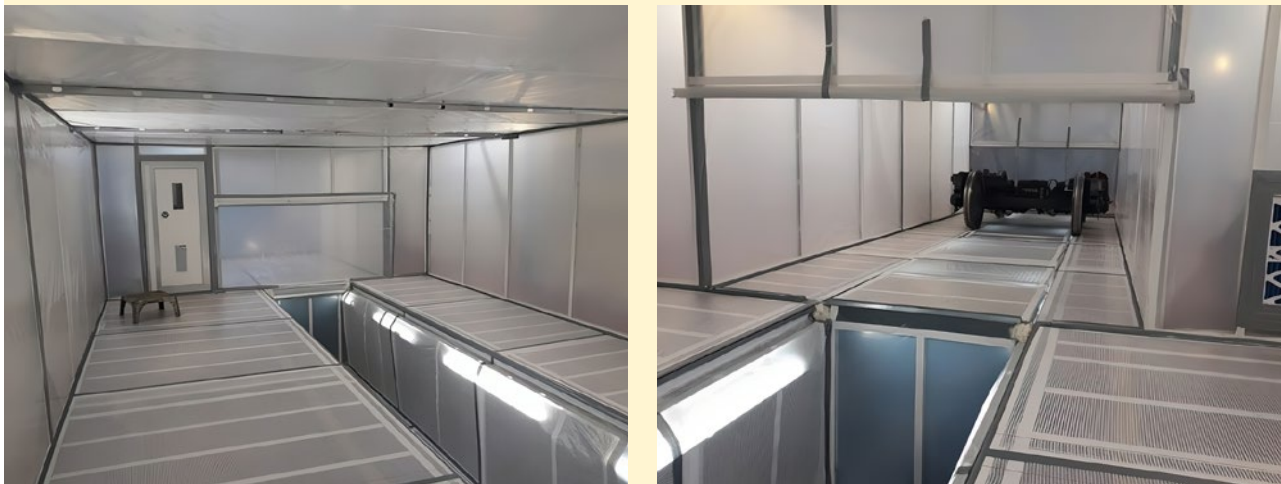
**Box 14-1: Example of an asbestos removal plan at a major European train operator****Figure 14-4: Large containment unit with a pit for bogies**

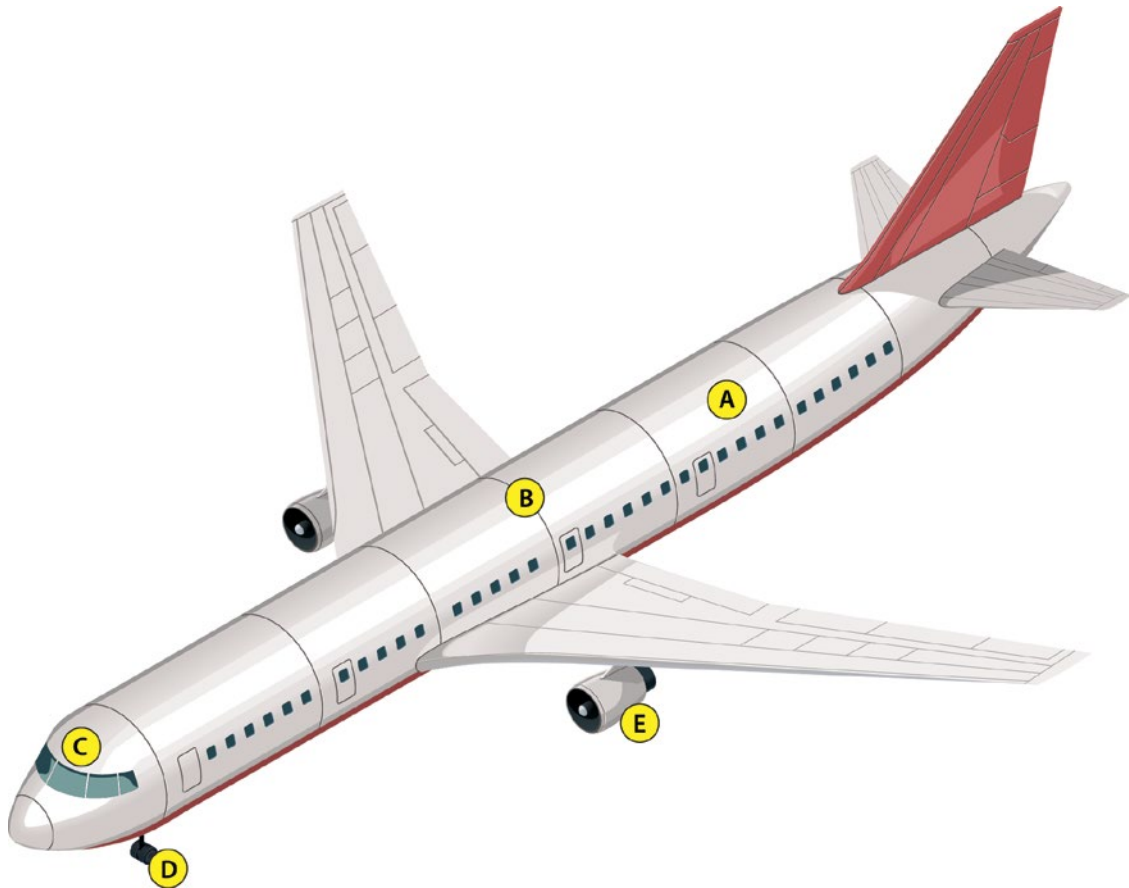
Figure 14-5: Aircraft – where asbestos might be found (non-exhaustive)

#### A: Fuselage

#### B: Air conditioning

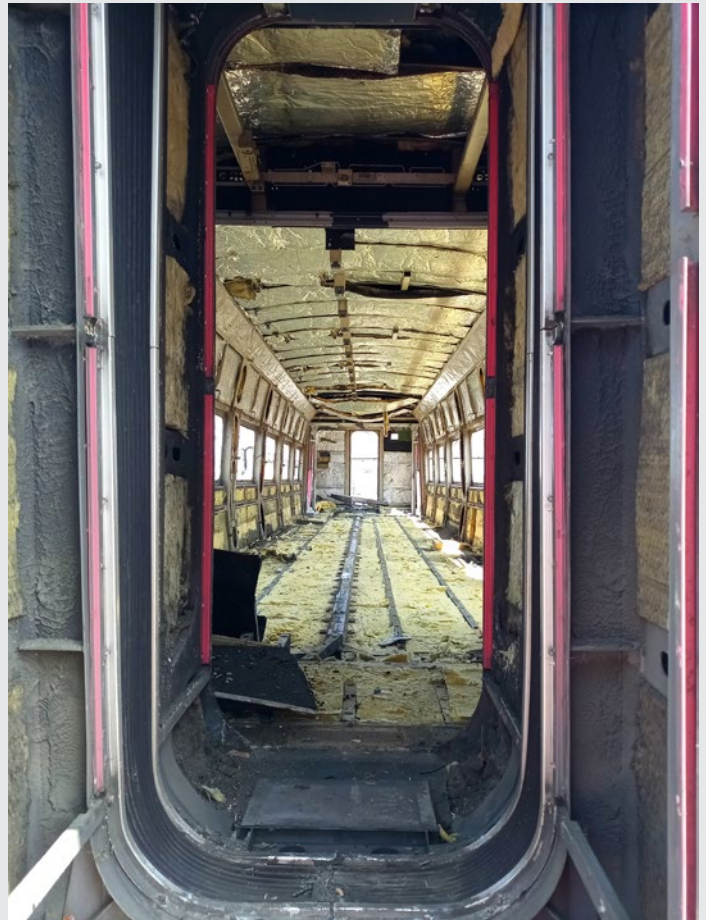
**Figure 14-7: Train carriage following the removal of non-hazardous components, awaiting asbestos removal at a train dismantling facility in France**

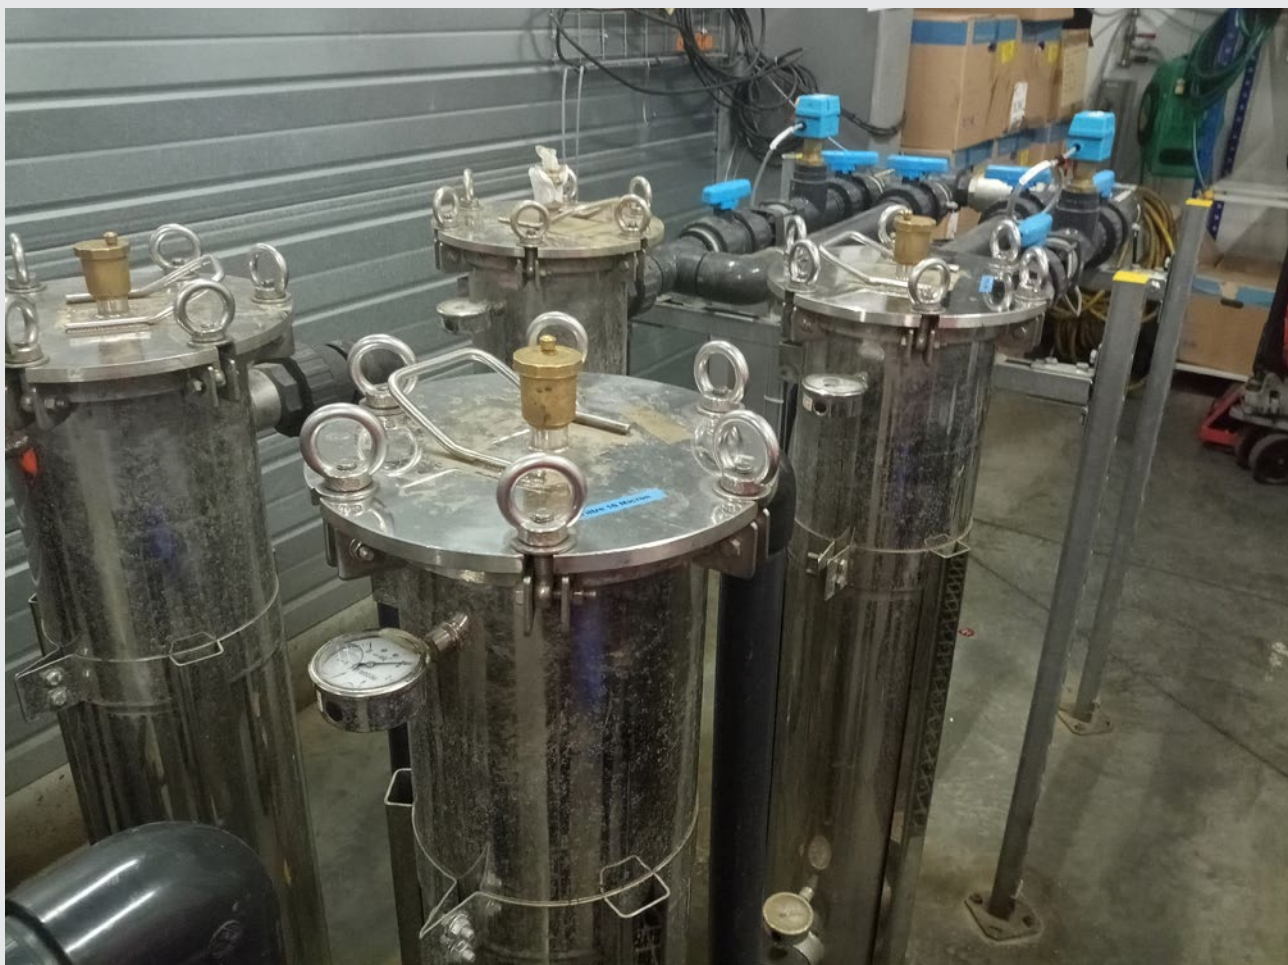
Figure 14-9: Filters to remove asbestos fibres from waste water at a train dismantling facility in France

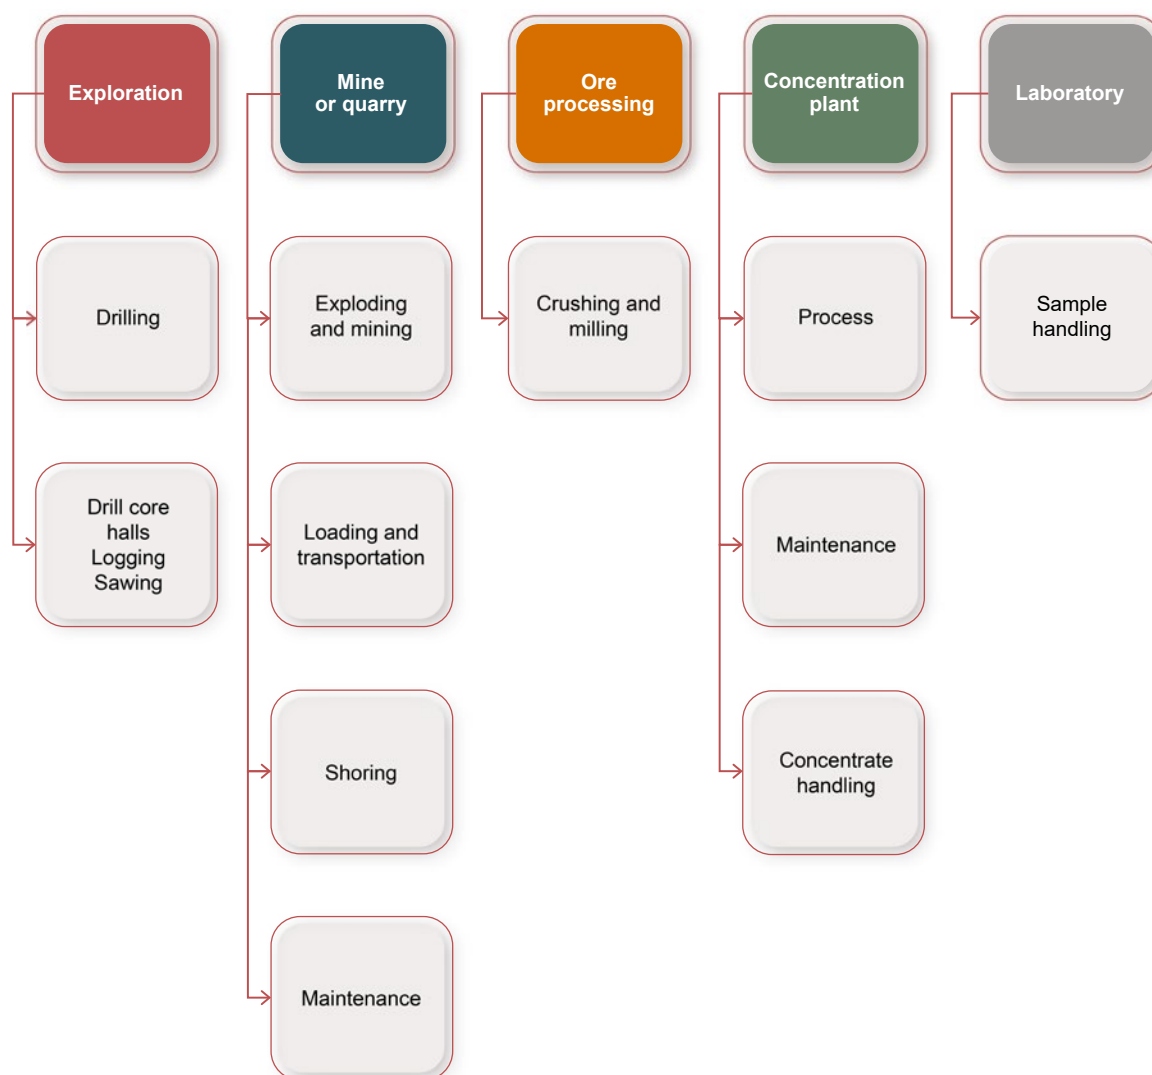
Figure 15-2: Division of mining or quarrying operations into measurement compartments and areas

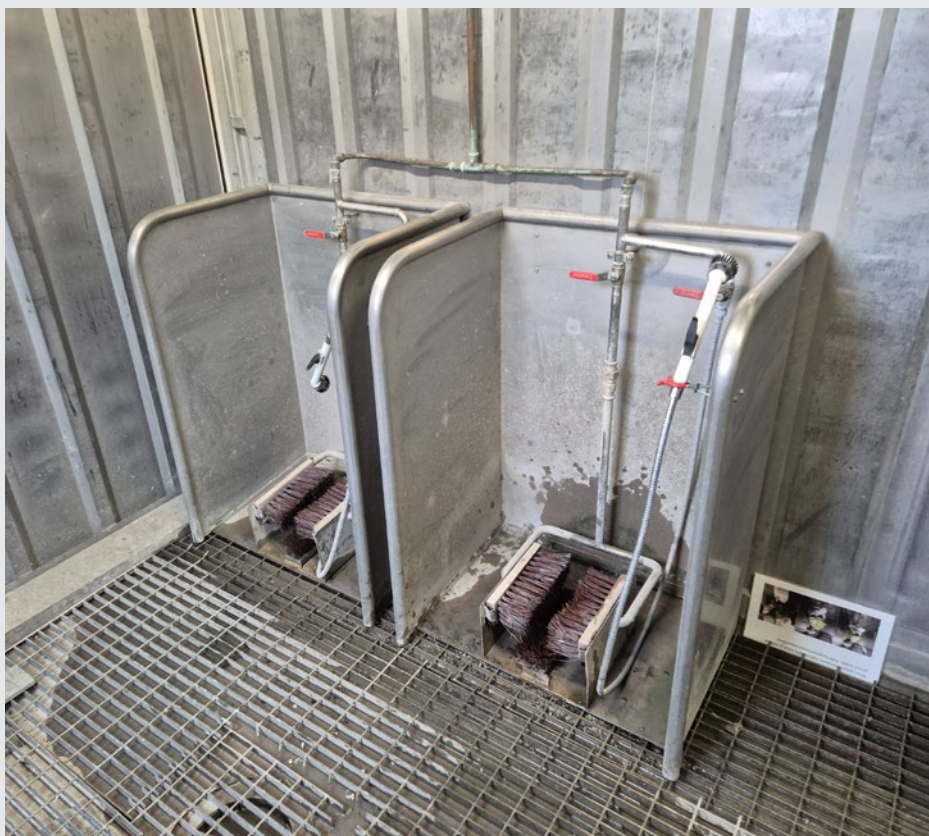
**Figure 15-3: Footwear washing facilities inside a decontamination chamber**

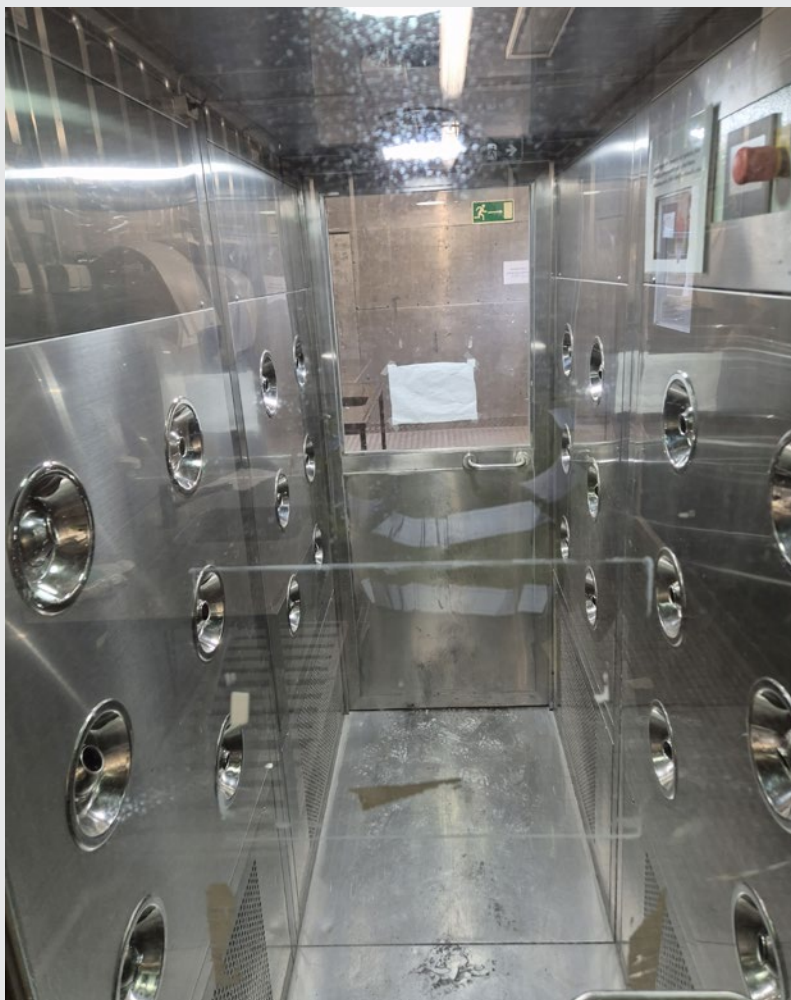
**Figure 15-4: In a decontamination chamber, air jets can be used in an air lock to remove any remaining dust from PPE after vacuuming, by circulating air downwards**

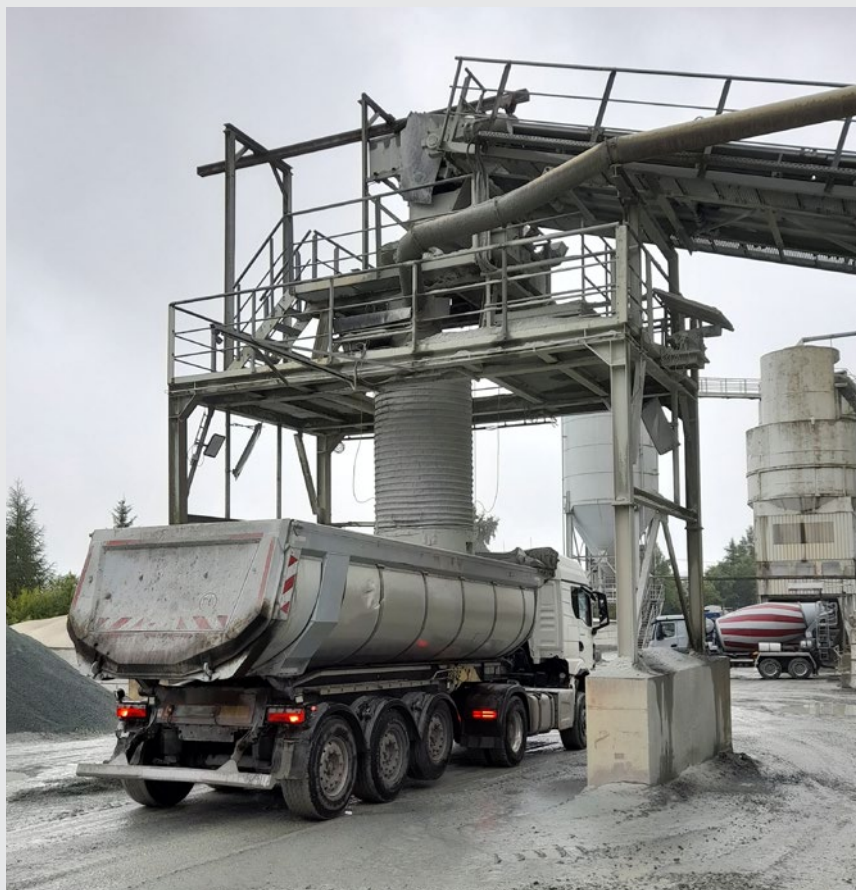
**Figure 15-5: Height-adjustable truck-loading spout with dustproof skirt**

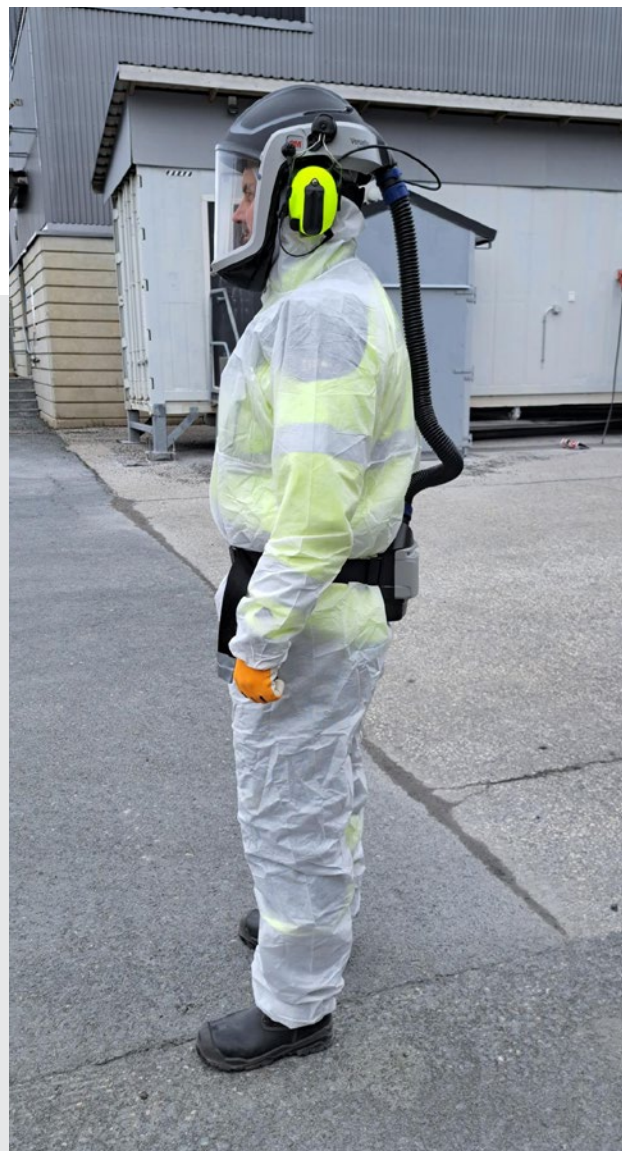
**Figure 15-7: PPE for a mine worker, including an RPD**
