# Guidelines for **managing asbestos related health and safety risks** at work

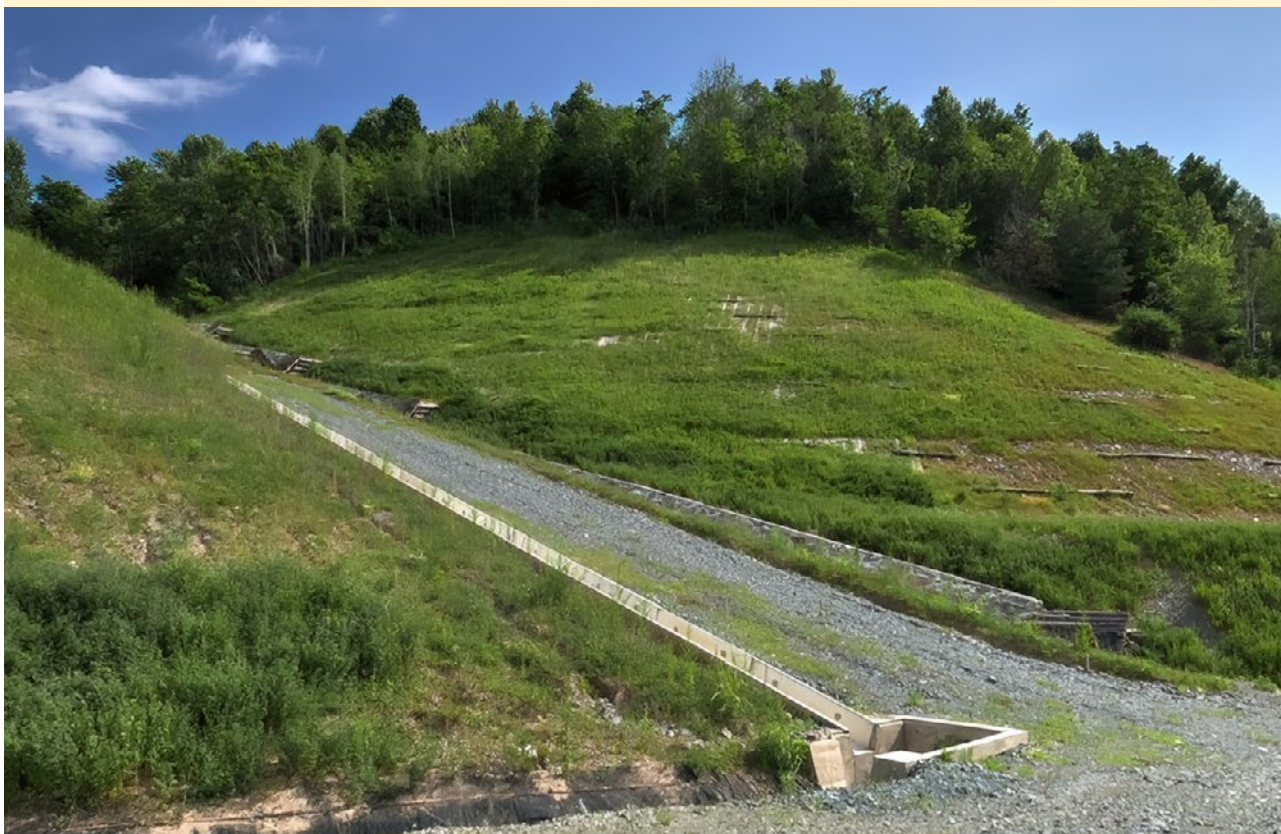
**Figure 15-10: Area A after remediation: stabilised slopes covered in vegetation prevent the release of airborne dust**

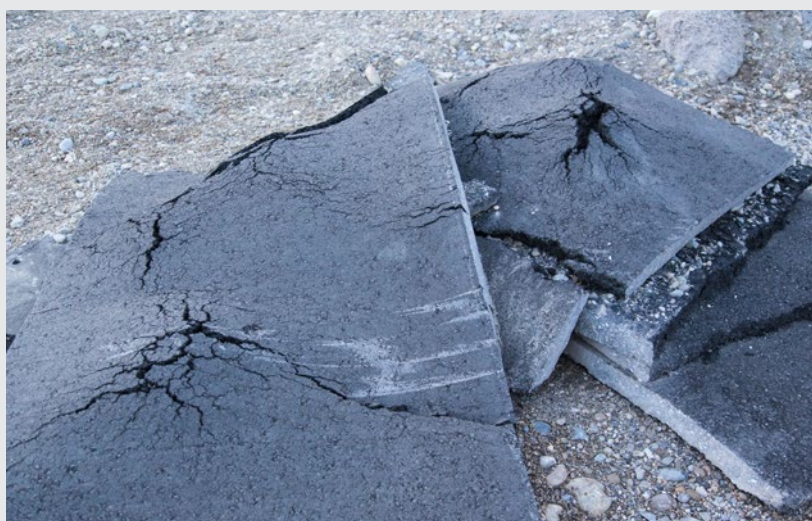
**Figure 16-1: Asphalt containing asbestos**

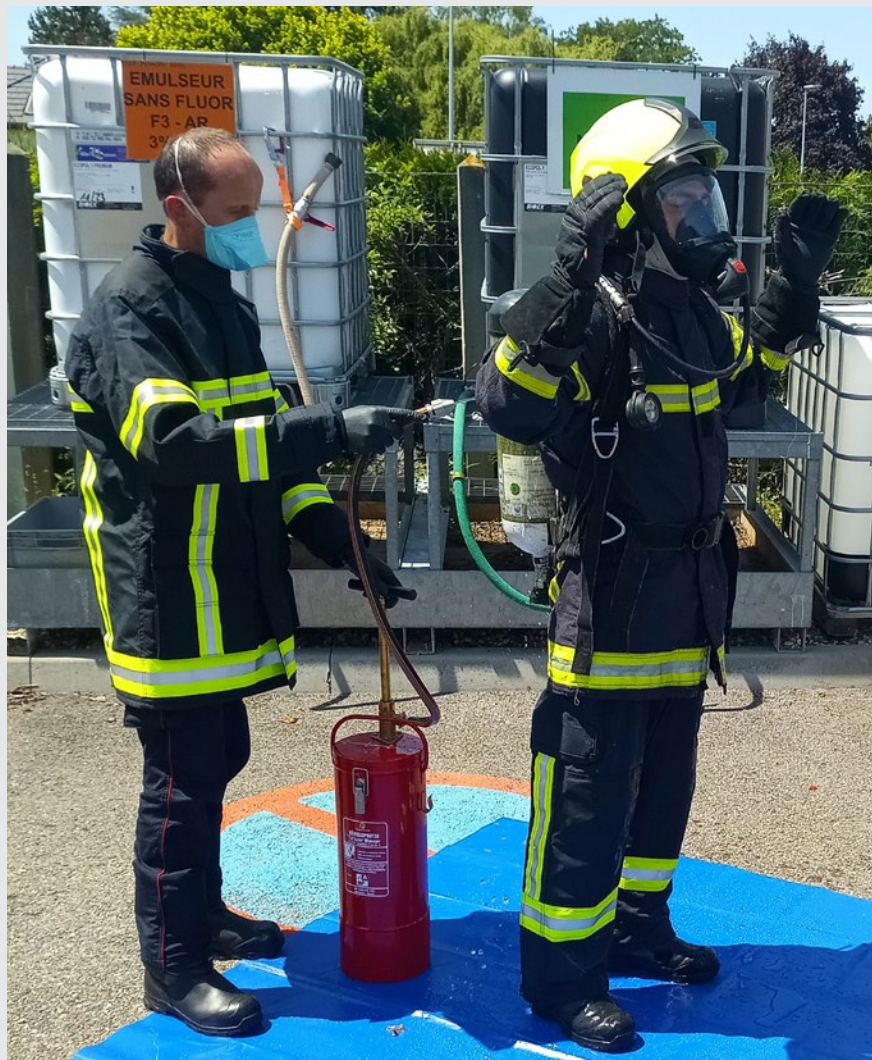
Figure 17-1: A firefighter wearing thermal protective PPE and a self-contained breathing apparatus (SCBA), undergoing the initial stage of asbestos decontamination at the fire site

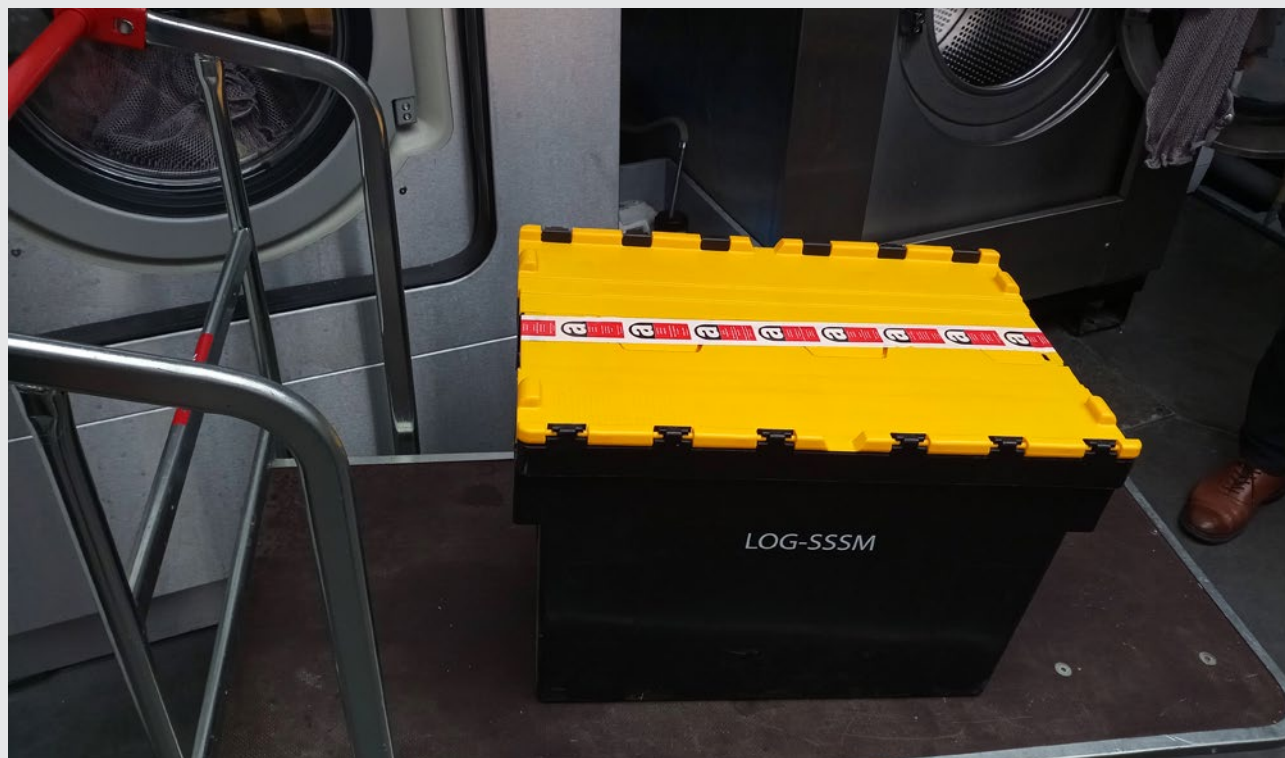
**Figure 17-2: Sealed box containing asbestos-contaminated clothing and equipment for thorough cleaning at the fire station**

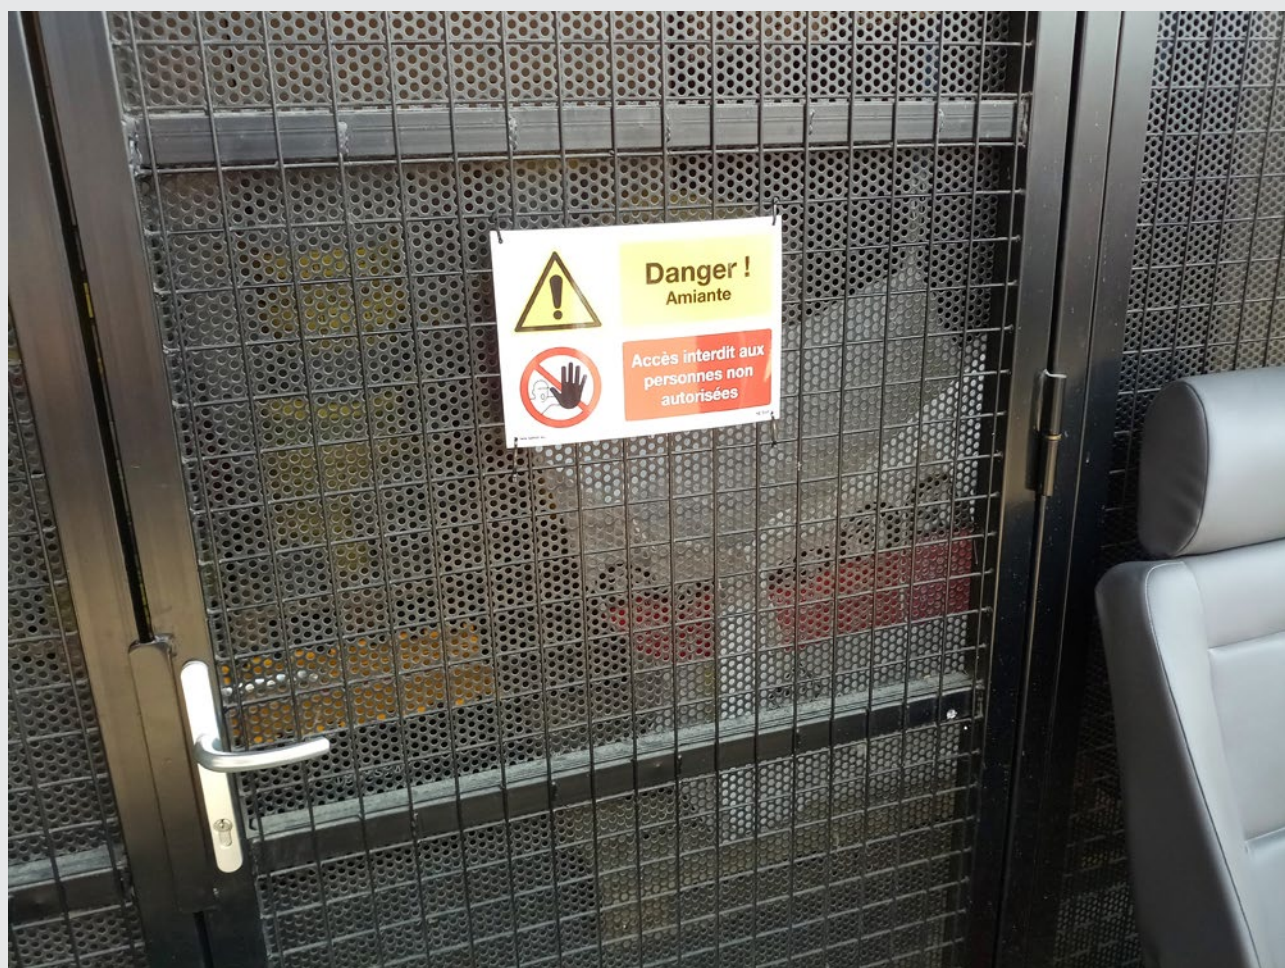
Figure 17-3: WCA from decontamination at a fire station stored in a secure area before appropriate disposal

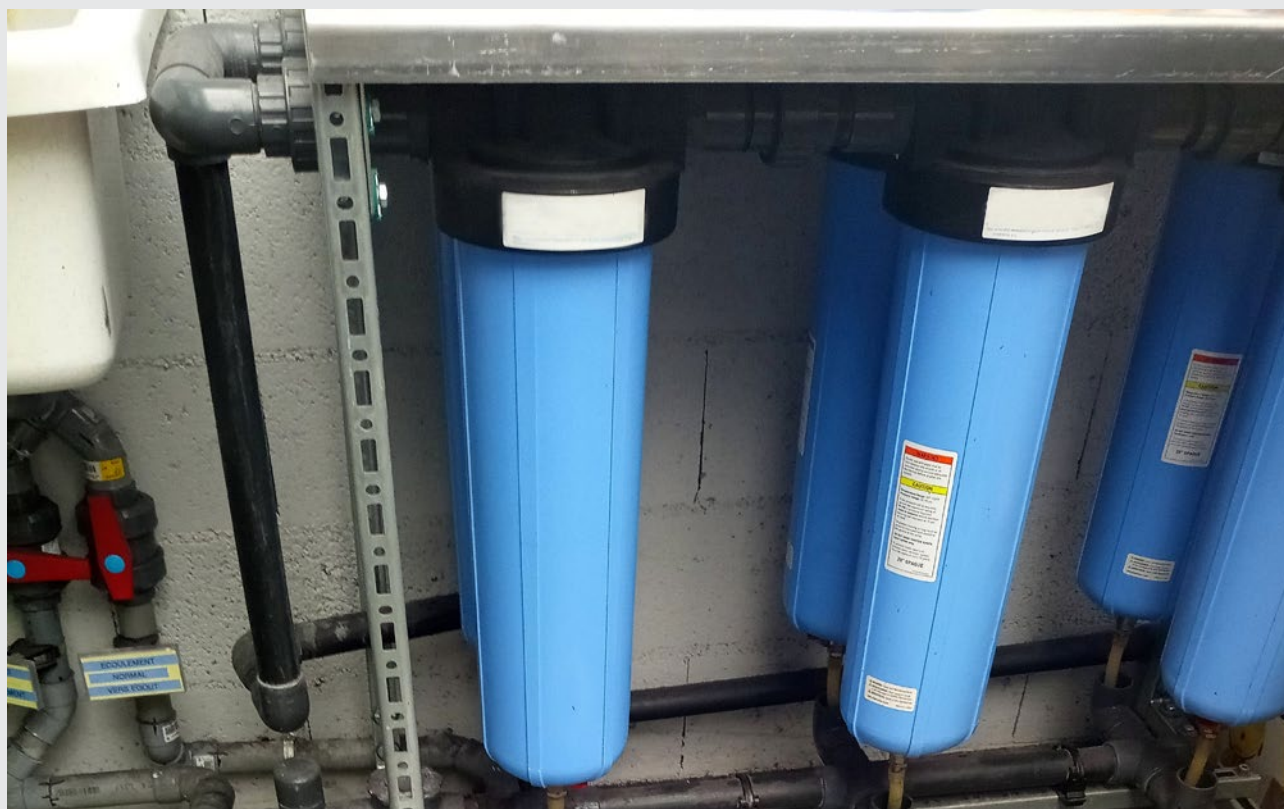
**Figure 17-4: Filters installed in a fire station to remove asbestos fibres from waste water**

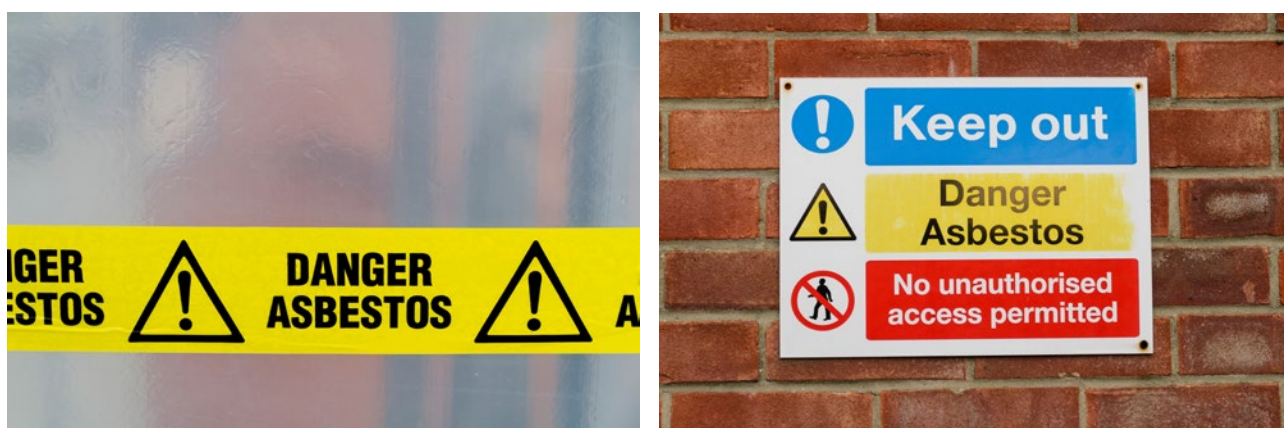
Figure A12-3: Examples of warning signs indicating an asbestos working area
